PORT AND HARBOUR RESEARCH INST TOKYO (JAPAN)
APPARENT WASTING INDEX OF EMBANKMENTS.(U)
DEC 76 F TERUAKI, I MOTOHARU

4. TITLE (and Subtitle) APPARENT WASTING INDEX OF EMBANKMENTS, ⑥		5. TYPE OF REPORT & PERIOD COVERED
7. AUTHOR(s) ⑩ Furudo, Teruaki Iguchi/Motoharu		6. PERFORMING ORG. REPORT NUMBER Technical Note, No. 149 ✓ 8. CONTRACT OR GRANT NUMBER(s)

9. PERFORMING ORGANIZATION NAME AND ADDRESS The Port and Harbor Research Institute Ministry of Transportation Tokyo, Japan		10. PROGRAM ELEMENT, PROJECT, TASK AREA & WORK UNIT NUMBERS

- I. Preface
- II. Wasting of Coastal Embankments
- III. Wasting of Coastal Embankments and Wasting Indicators
 - A. Causes of Damages to Coastal Embankments and Sea Walls

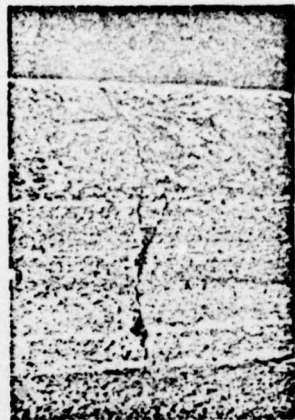
Photo 5.2 - Condition of Masonry (scoured masonry)

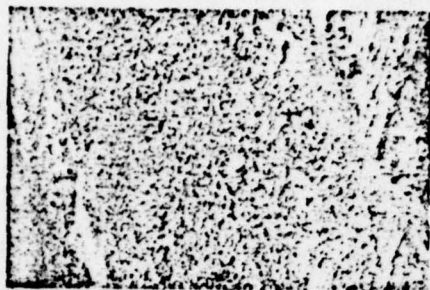
Photo 5.40 - Abrasion of Face Spread Concrete

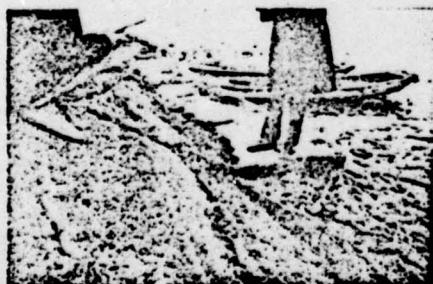
Photo 5.51 - Sinking Slippage of Face Spread

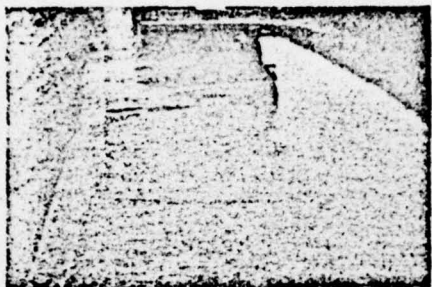
写真-5.55 天板工の沈下、水溜り
Photo 5.55 - Sinking and Water Puddles of Crown

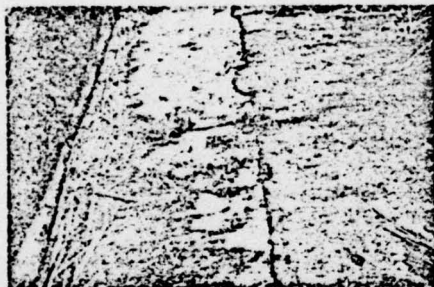
Photo 5.59 - Crown Crack

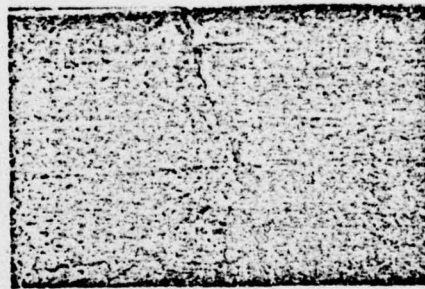
Photo 5.63 - Wave Deflector Crack

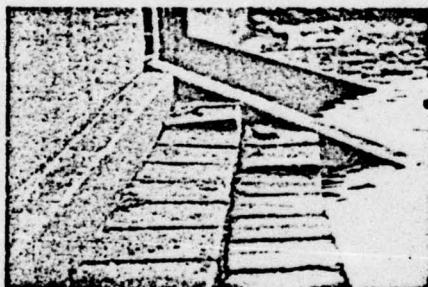
Photo 5.77 - Sinking Condition of the Front

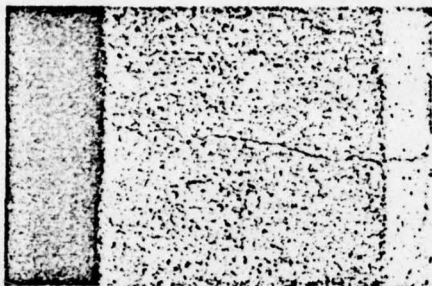
Photo 5.107 - Crack of Wave Deflector (upper surface)

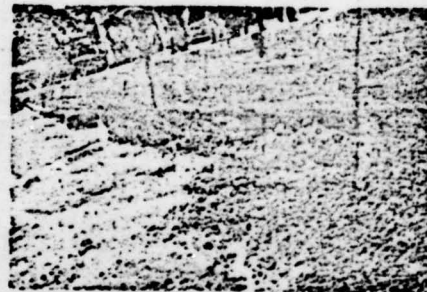
Photo 5.110 -
Damage of
Face Concrete

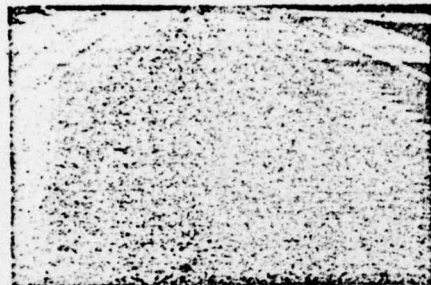
Photo 5.115 - Crack of Apron (road surface) (normal line)

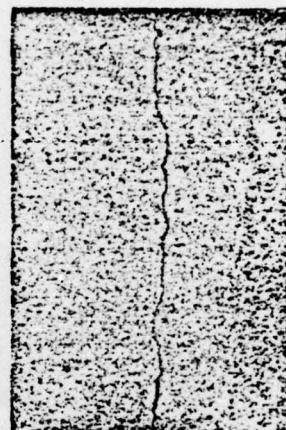
Photo 5.119 -
Crack of
Wave Deflect-
or

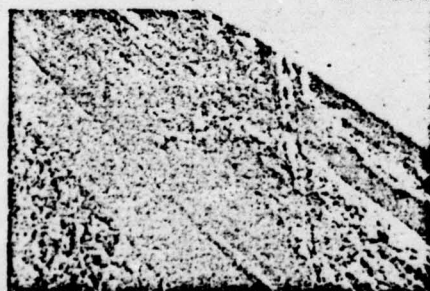
Photo 5.120 - Cracking
of Face Concrete

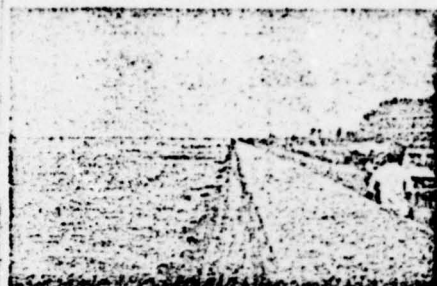
Photo 6.29 -
Conditions of
the Deflector
Face
Head

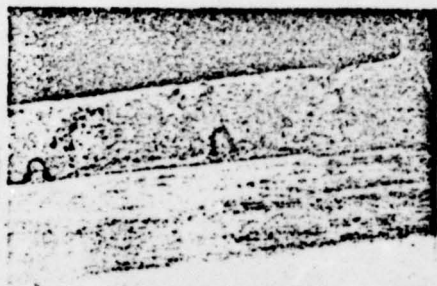
Photo 6.31 - Conditions of
Front of Sea Wall and Re-
inforced Bedding

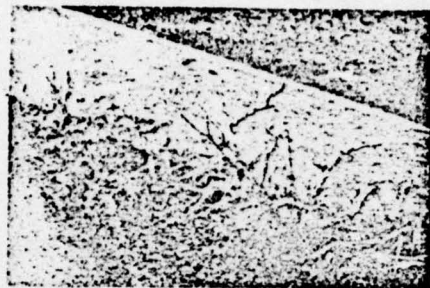
Photo 6.40 -
Crack of Wave
Director

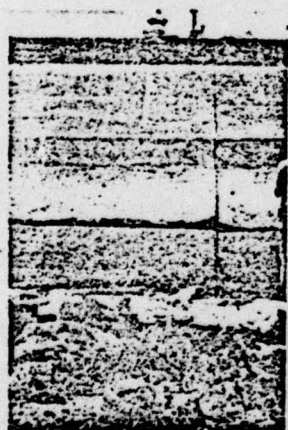
Photo 6.46 - Angular Break of Face Spread Lower Section at Ground Site

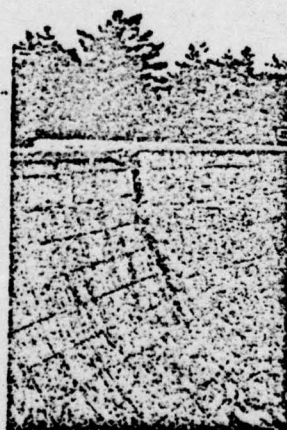
Photo 6.47 - Surface Abrasion and Soil Erosion at Ground Site of Wave Deflector
